Beam Column Connections for Multi-storey Timber Buildings

A Report
submitted in partial fulfilment
of the requirements for the Degree
of
Master of Engineering in Civil
in the
University of Canterbury
by
Robert Hugh Fairweather

University of Canterbury

1992

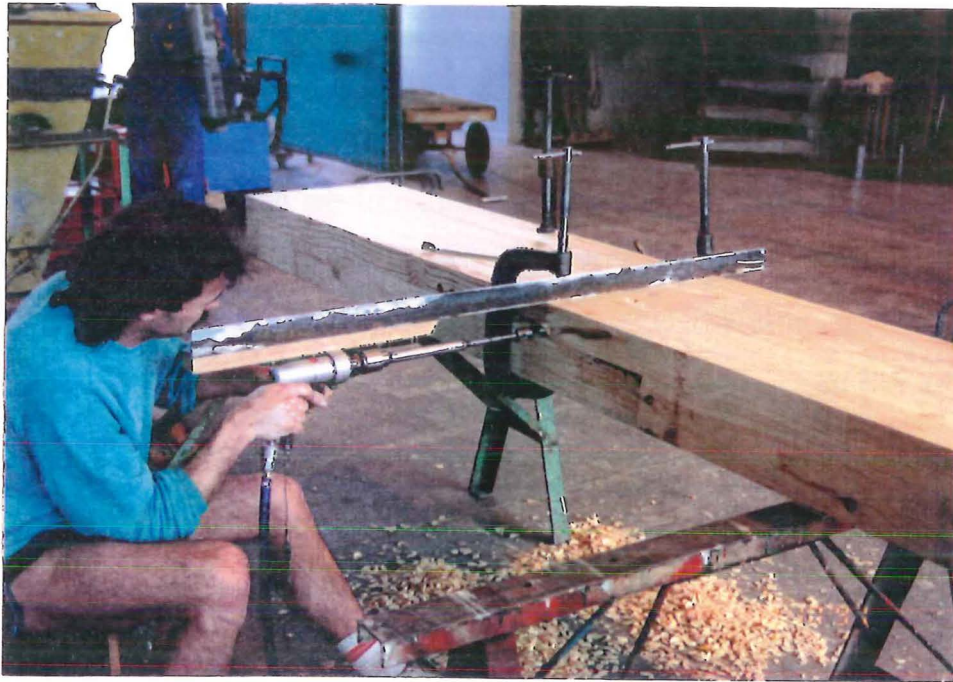
Figure 3.3 Method used to drill holes

Drilling alignment was achieved by using a steel angle guide as a reference to sight along, as shown in the Figure 3.3. All holes were thoroughly cleaned using compressed air.

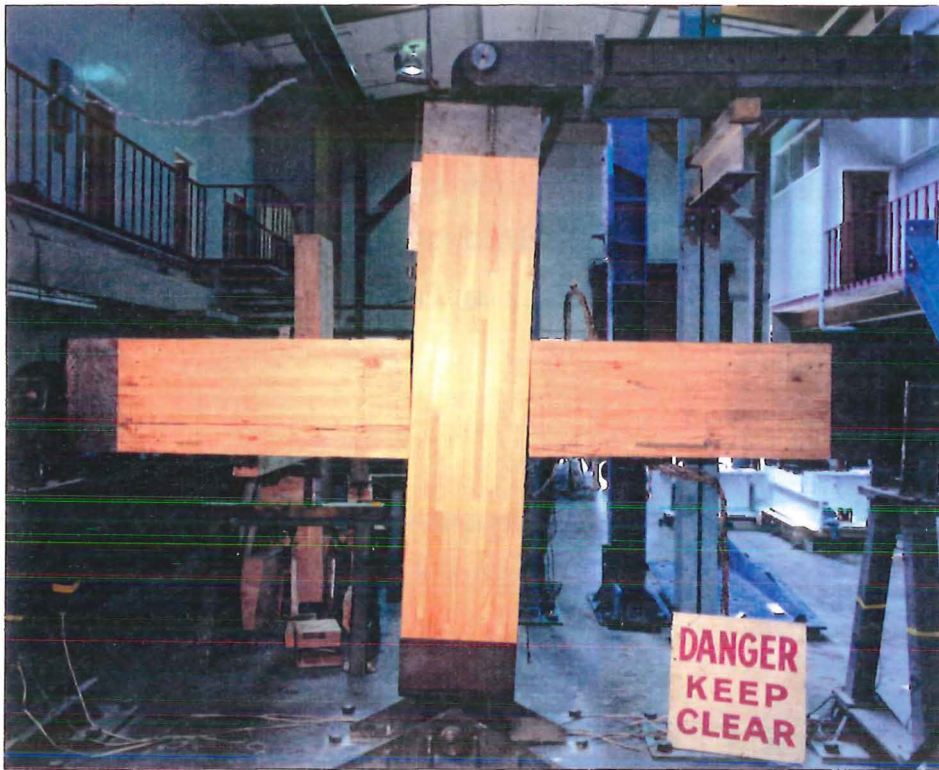
Figure 5.24 Overall view of Unit 8 at the end of test

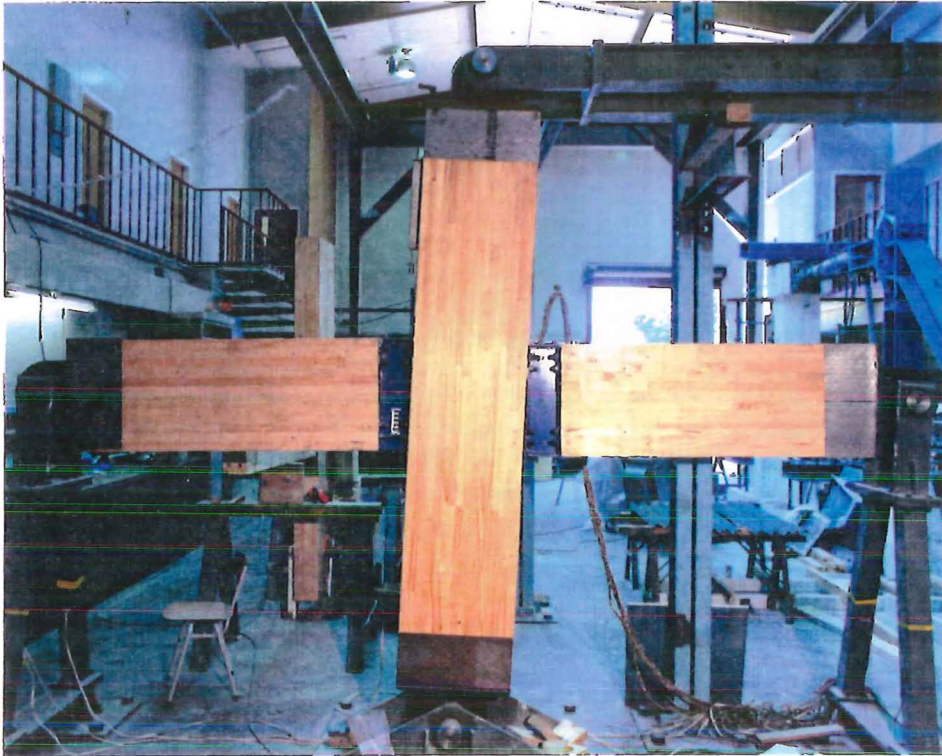
Figure 5.49 Overall view of Unit 6 at the end of test

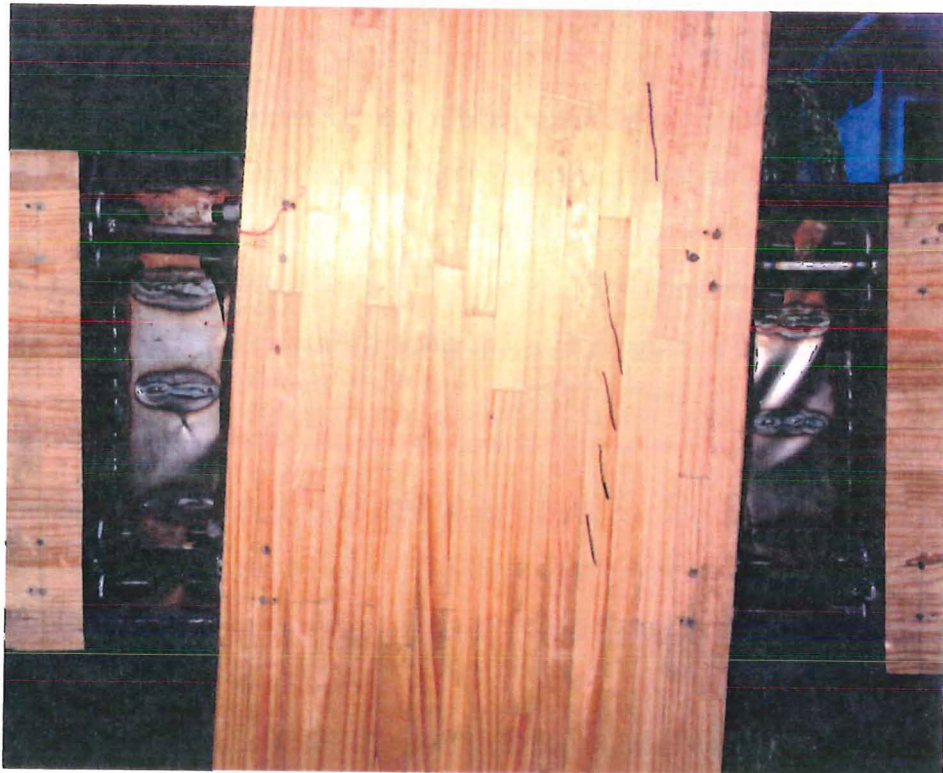
Figure 5.58 View of the joint region of Unit 7 at the end of the test
